STATIC FRACTURE BEHAVIOR
OF A CERAMIC MATRIX COMPOSITE
AT ELEVATED TEMPERATURES

Thesis

David M. Agins, Captain, USAF

Presented to the Faculty of the Graduate School of
Engineering of the Air Force Institute of Technology
Air University
In Partial Fulfillment of the
Requirements for the Degree of
Master of Science in Aeronautical Engineering

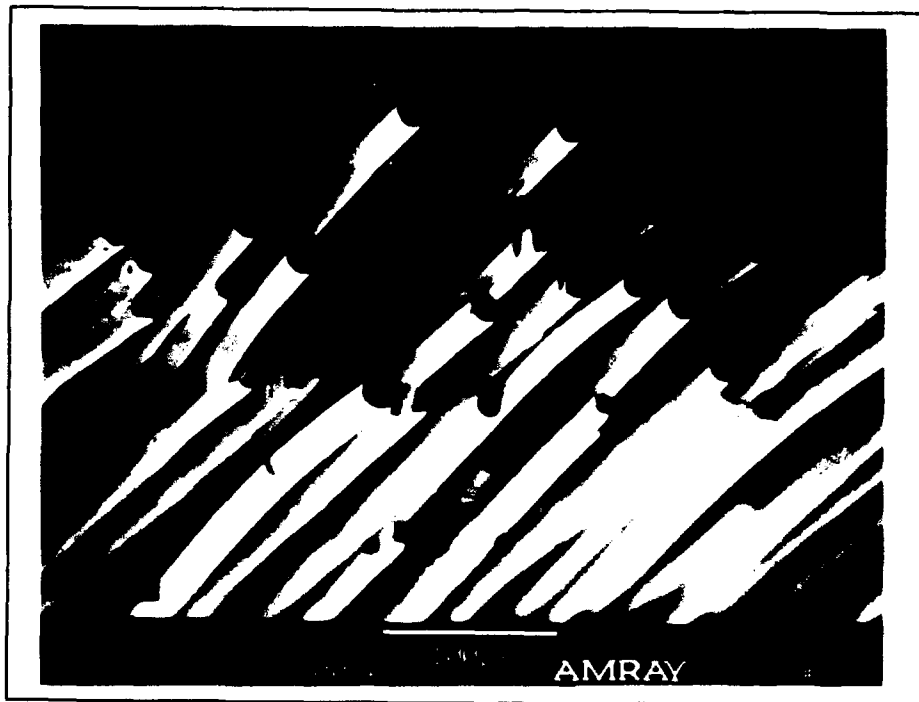
Figure 40. Fractured Fibers of Room Temperature Specimen

Figure 41. Fractured Fibers of Room Temperature Specimen

affects of oxidation. Figures 40 and 41 show the fibers of the room temperature test specimen. The fibers are clean and undamaged, indicating that the interface has not been affected. Figures 42 and 43 show the fibers of the 700° C test specimen; these fibers are also clean and undamaged. Figures 44 and 45 show the fibers from the 850° C test specimen. Debris on the fibers and variations in the fiber surface indicate oxidation has occurred.

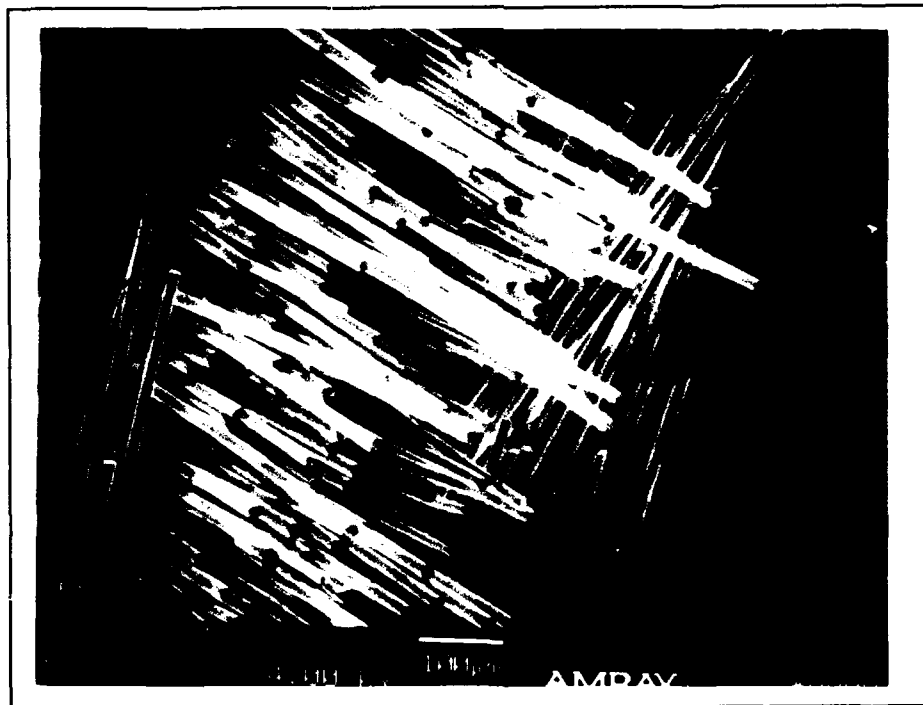
Figure 42. Fractured Fibers of 700° C Specimen

Figure 43. Fractured Fibers of 700° C Specimen
